NOTICE

1. Report No. 2. Government Accession No.	3. Recipient's Catalog No.
DOT/FAA/CT-TN93/7	
4. Title and Subtitle	5. Report Date
	December 1993
INITIAL EVALUATION OF BURN CHARACTERISTICS OF	6. Performing Organization Code
PHENOLIC FOAM RUNWAY BRAKE ARRESTOR MATERIAL	
	8. Performing Organization Report No.
7. Author(s)	
Dung Do, Joseph Wright and Lawrence Hampton	DOT/FAA/CT-TN93/7
9. Performing Organization Name and Address	10. Werk Unit No. (TRAIS)
Federal Aviation Administration	17. Contract or Grant No.
Technical Center	
Atlantic City International Airport, NJ 08405	13. Type of Report and Period Covered
12. Sponsoring Agency Name and Address	- Type of Repair and Control
U.S. Department of Transportation	Technical Note
Federal Aviation Administration	
Technical Center	14. Sponsoring Agency Code
Atlantic City International Airport, NJ 08405	
15. Supplementary Notes

Tests of the burn characteristics of a phenolic foam, under evaluation as a runway brake arrestor material, were conducted by the Fire Safety Branch of the Federal Aviation Administration (FAA) Technical Center.

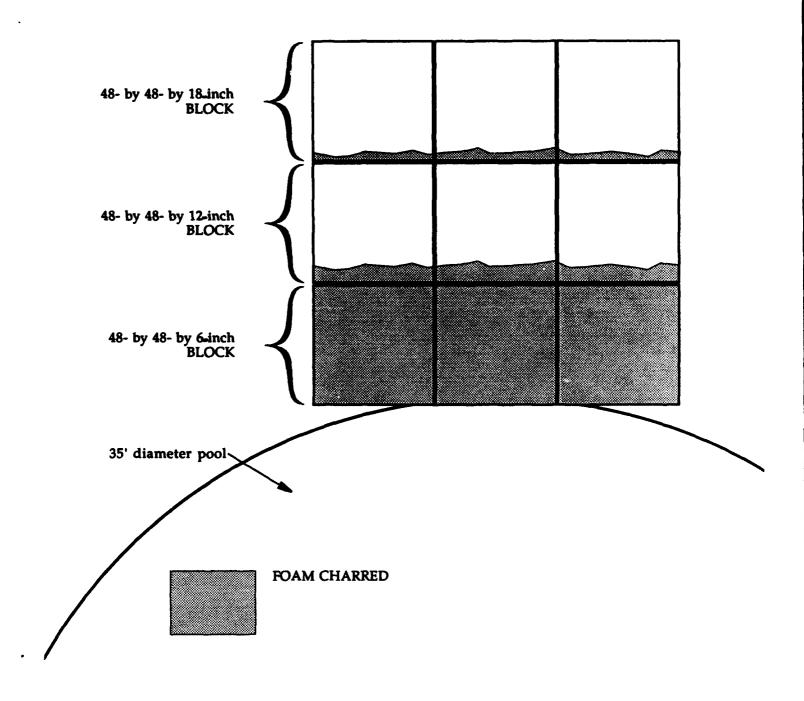
FIGURE 9. PRINCIPAL FIRE DAMAGE -- SURFACE OF PHENOLIC FOAM

- 1. Over one-third of the surface of the blocks of foam was charred (figure 9)
- 2. The surface of the 6-inch-thick block was totally charred and buckled (figure 9).

- 3. The surface of the 12-inch-thick block located next to the 6-inch-thick block was charred for 2 inches from all leading edges.
- 4. The surface of the 18-inch-thick block located next to the 12-inch-thick block was charred for 1/2 inch from all leading edges.

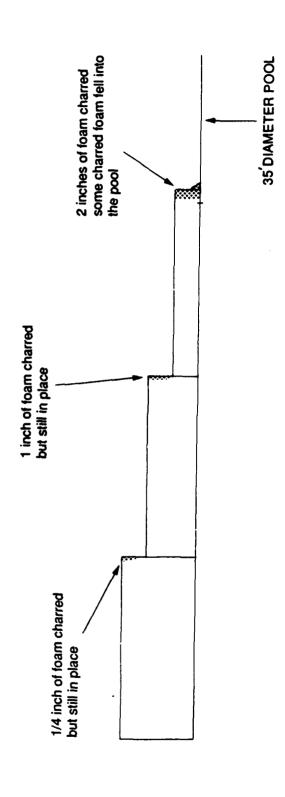
FIGURE 10. SIDE VIEW OF CHARRED SURFACES OF THREE BLOCKS OF FOAM

- 5. All leading edges of the 6-inch-thick phenolic foam side were charred and buckled about 2 inches into the foam. Some charred debris had fallen into the pool fire (figure 10).

- 6. One inch from the leading edges of the 12-inch-thick phenolic foam side facing the 6-inch-thick block was charred and buckled but remained in place.

- 7. The 18-inch-thick phenolic foam side was charred about 1/4 inch from the leading edges.
- 8. All three phenolic foam block bottoms were intact except for slight damage to the leading edge bottom of the 6-inch block.

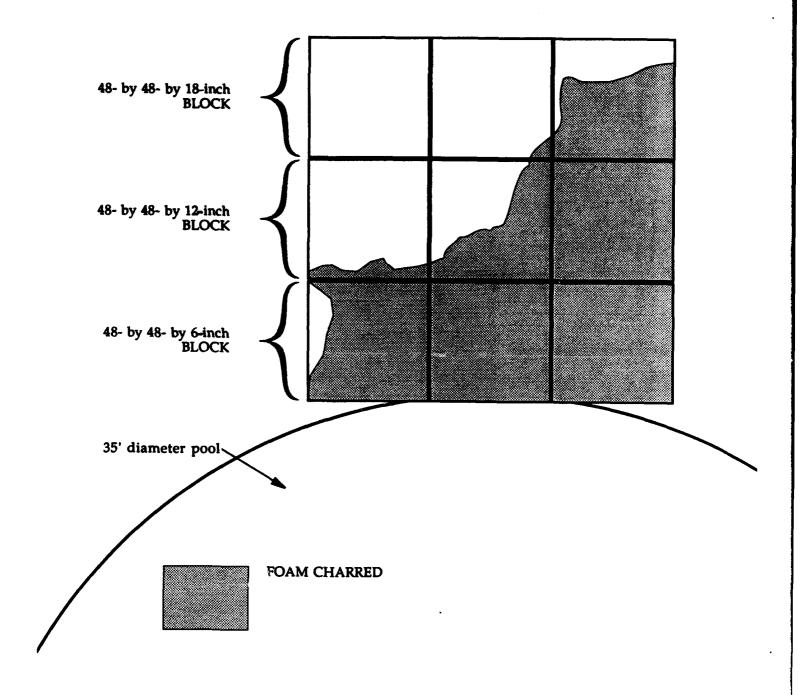
FIGURE 17. PRINCIPAL FIRE DAMAGE SURFACE OF PHENOLIC FOAM

- 1. Over 50 percent of the surface of the blocks of foam was charred (figure 17).
- 2. The surface of the 6-inch-thick phenolic foam block was totally charred and buckled (figure 17).

- 3. The surface of the 12-inch-thick and 18-inch-thick phenolic foam blocks were charred as shown in figure 17.
- 4. All leading edges of 6-inch-thick foam side were charred about 2 inches into the foam, and some charred debris had fallen into the pool fire (figure 18).

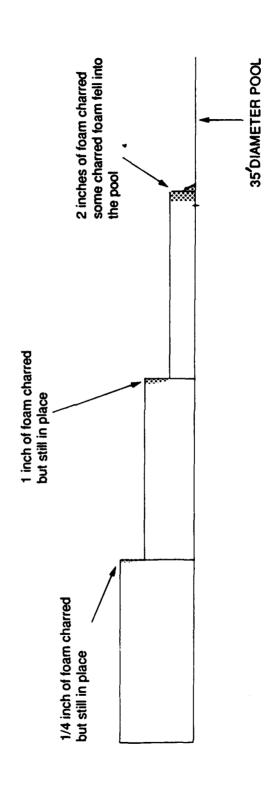
FIGURE 18. SIDE VIEW OF CHARRED SURFACES OF THREE DIFFERENT THICKNESSES OF FOAM

- 5. Approximately 1 inch from the leading edges of the 12-inch-thick foam side was charred and buckled but still intact.
- 6. The 18-inch-thick foam side was charred for approximately 1/4 inch from the leading edges.
